Article

Contemporary Challenges for Heating Historic Church Buildings from the Late 19th and Early 20th Centuries

Faculty of Civil Engineering, Architecture and Environmental Engineering, Lodz University of Technology, Al. Politechniki 6, 90-924 Lodz, Poland; tomasz.jerominko@p.lodz.pl (T.J.); artur.zagula@p.lodz.pl (A.Z.)

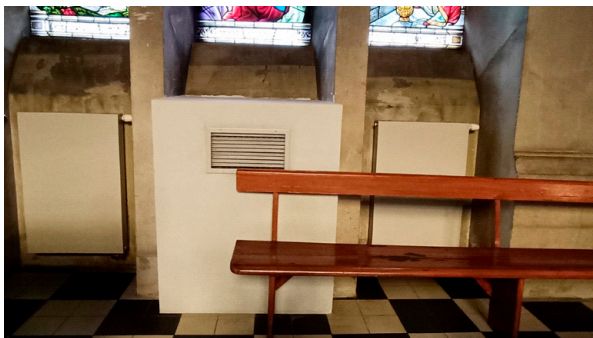
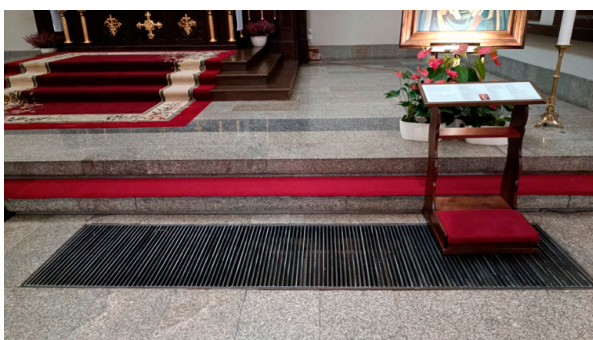
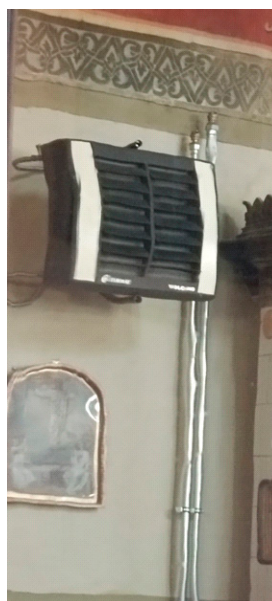
Figure 7. Areas of higher heat demand and heating.

(A) Areas of higher heat demand. Auth. T. Grzelakowski

(B) St Kostka Heating. Auth. A. Zagula

(C) St Olga, Heating Auth. A. Zagula

The usage patterns of churches pose a significant challenge in selecting an appropriate heating system (Figure 7). These buildings often experience long periods of vacancy interspersed with short periods of high occupancy during services, such as the one to two-hour services on Sundays at St. Mathew Church. This irregular schedule demands a heating system capable of quickly adjusting to significant temperature requirements within short timeframes [29]. Additionally, the financial aspect is critical, encompassing both the costs of renovation and ongoing operation. The challenge is compounded by the large space and inefficient thermal envelope of heritage buildings, necessitating insulation solutions that are not only effective but also economically viable [30].

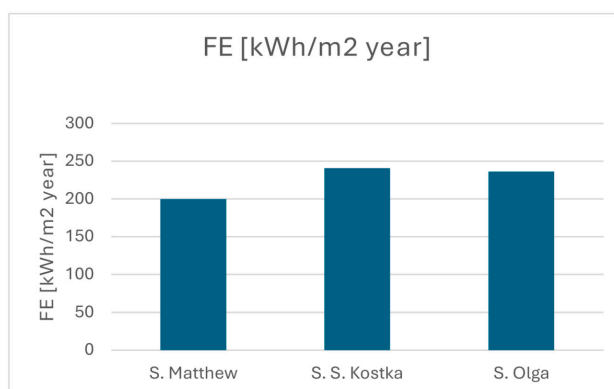
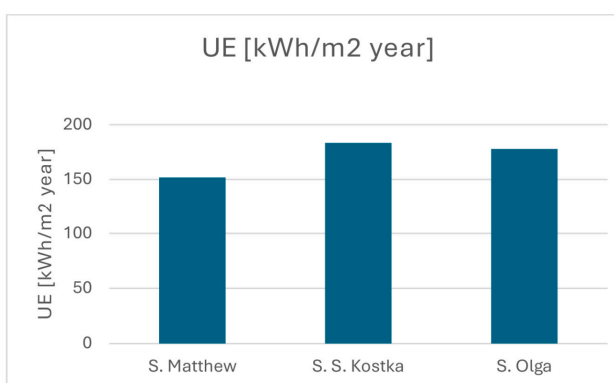
**Figure 9.** Comparison of energy indicators.

(A) Comparison of the primary energy index for the analyzed church buildings

(B) Comparison of the final energy index for the analyzed church buildings

(C) Comparison of the useful energy index for the analyzed church buildings

The results of these indicators for the analyzed buildings are detailed in Figure 9.

The calculated indicators for each of the studied buildings showed similar values. The PE index was between 122.6 kWh/m²/year for the church of St. Matthew (A) and 147.3 for the Archcathedral Basilica of St. S. Kostka (B). However, the FE index was in the range of 199.6–240.8 kWh/m²/year, and the EU index was 151.6–183.2 kWh/m²/year. The similar values for the designated indicators may be explained by the fact that the analyzed religious buildings are in the same climatic zone, were built during the same period, use similar building materials, and employ very similar heating methods. Approximately 15–20% of their energy consumption is used for lighting. The rest is used for heating and ventilation. Similar energy consumption values have been reported for other religious buildings located in other regions and climatic zones (e.g., in Indonesia or the USA), although in those cases, lighting accounted for the highest energy use [41,42]. The calculated energy consumption in the buildings is consistent with data from the literature [37], assuming that the energy needs for church exploitation are approximately 900 h/a under full strain with a base temperature of 8 °C.
